# Manhole Inspection Summary

Manhole # S47II\_035MH

Insp Date: **5/1/08 9:36 AM**

**Location** Address: **Federal St**

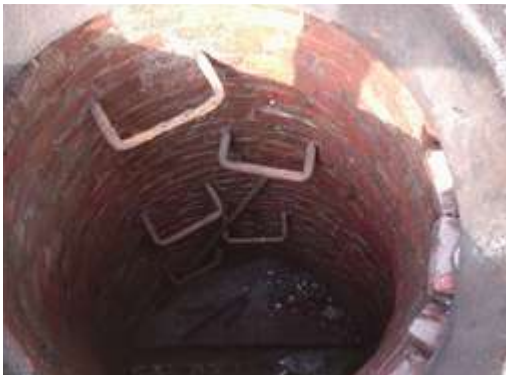
Defect 2

Deterioration

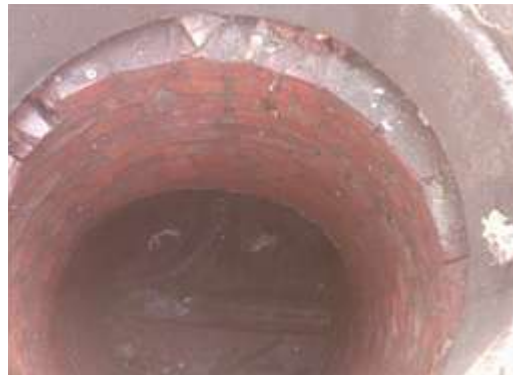
Defect 1

Infiltration

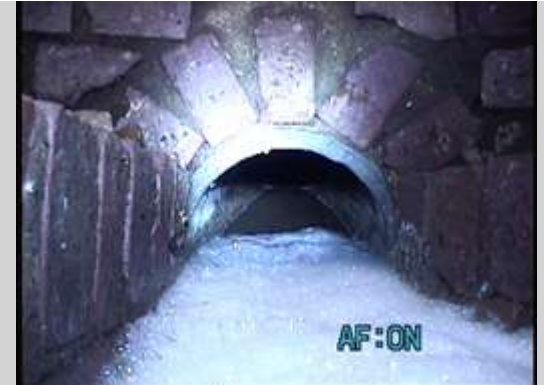
12 O'Clock Outflow

8 in. Circular Gravity Sewer  
Pipe Out @ 12 O'Clock

Pipe Height: **8.4** (in.) Rod and Bar (Angled)  
Pipe Material: **Clay** ☐ Pipe Lined  
Invert Depth: **9.70** (ft.) Flow Characteristics: **Fast**  
Deposits: ☒ None ☐ Mud ☐ Sludge ☐ Debris ☐ Grease  
Silt Depth: (in.) Deposits Extent:  
Infiltration: **None** Pipe Seal Cond: **Sound**

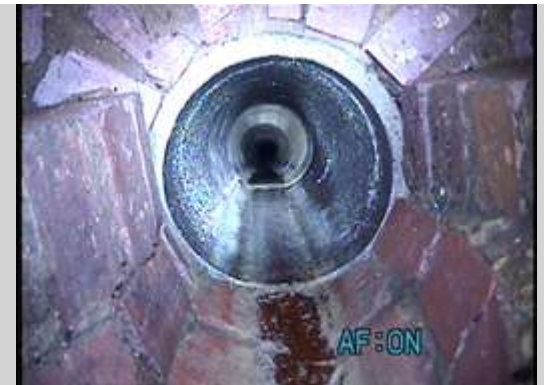
3 O'Clock Inflow

8 in. Circular Gravity Sewer  
Pipe In @ 3 O'Clock

Pipe Height: **8.4** (in.) Rod and Bar (Angled)  
Pipe Material: **Clay** ☐ Pipe Lined  
Invert Depth: **9.35** (ft.) Flow Characteristics: **Fast**  
Deposits: ☒ None ☐ Mud ☐ Sludge ☐ Debris ☐ Grease  
Silt Depth: (in.) Deposits Extent:  
Infiltration: **None** Pipe Seal Cond: **Sound**

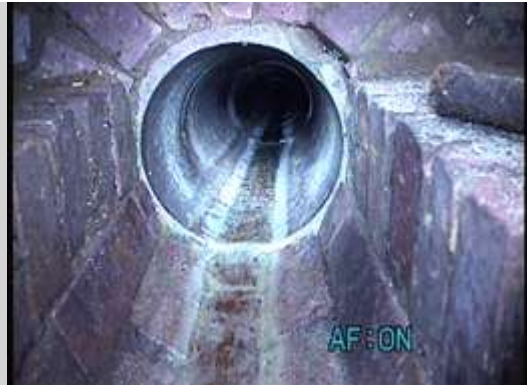
6 O'Clock Inflow

8 in. Circular Gravity Sewer  
Pipe In @ 6 O'Clock

Infiltration: **None** Pipe Seal Cond: **Sound**
